FINAL REPORT

Fall Mission: October 26, 2010 – December 21, 2010

“Conservation and Documentation of the Wall Paintings at the Red Monastery, Sohag”

Sub-grant No. EAC-28-2010

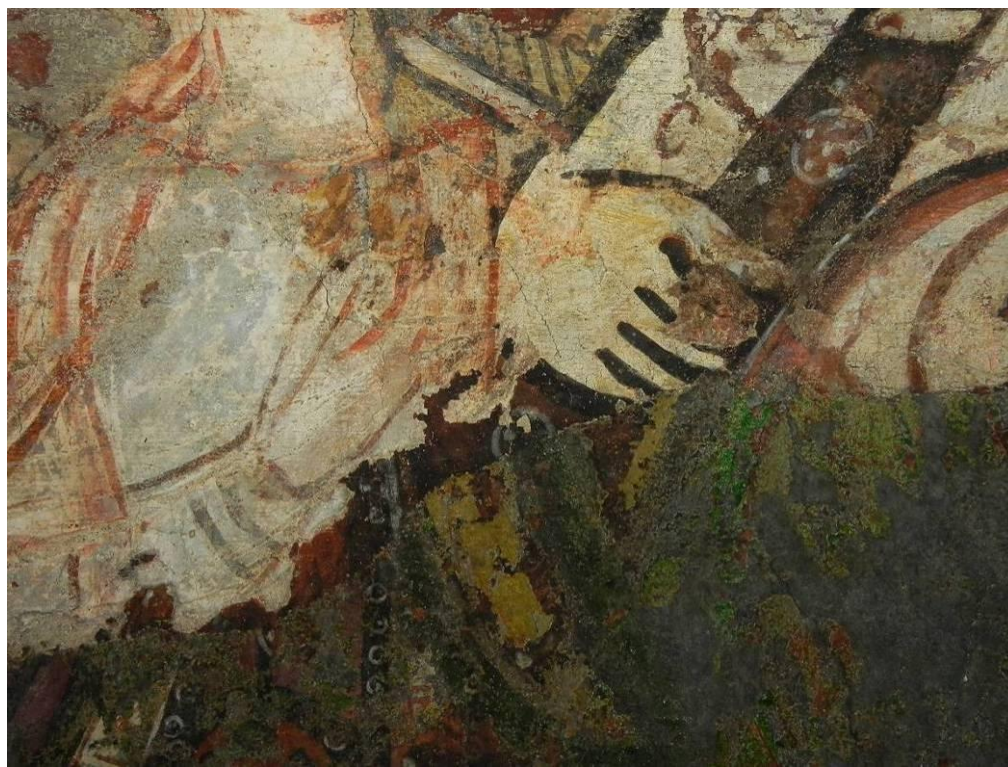
Figure 7

As we will describe below, both the third-phase plaster and the whitewash with the fourth-phase paint layer fell or were removed from a large central area. This was the state of affairs when the individual we now call the “fourth-phase plus” painter primed the surface of the semi-dome. Having the same materials at his disposal, he used an only slightly thinner whitewash. Before applying the whitewash, the painter carried out a limited amount of pointing along the edges of the gaps in the plaster in order to even out the irregularities in the palimpsest (Figure 7).

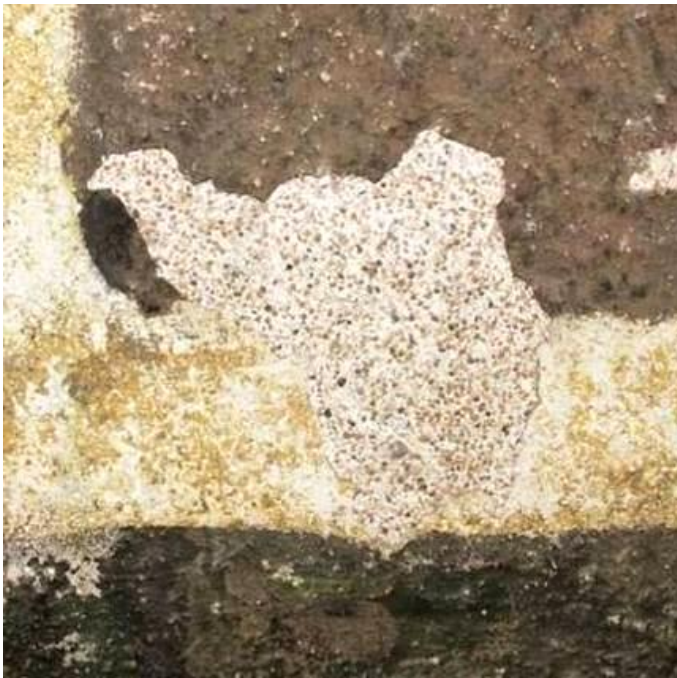
Figure 8

The third-phase plaster has the same features as that in other parts of the church. The plaster was applied in a layer varying from approximately 0.5 to 1 cm in thickness (the thickness diminishes on the moldings and column shafts), is lime-based and contains large, smooth, round grains of quartz sand² (Figure 8). It has a very smooth, almost burnished surface. As we have observed for some time, the surface of this plaster appears smooth and less granular than the third-phase plaster of the higher tiers and, under close examination, the mortar proves to contain finer and more irregular sand³.

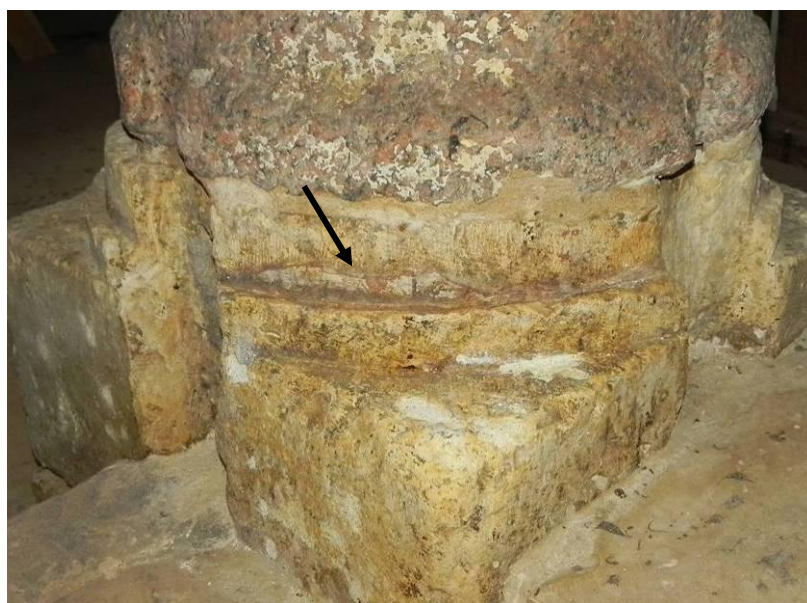
Figure 11

A few fragments of whitewash, presumably dating from the late antique, are visible on the shafts of the monumental columns in this area. Sizeable portions of a pinkish plaster can also be seen on the column bases (Figure 11). The limestone column bases were originally coated with this red plaster to make them tone in with the granite columns above them.

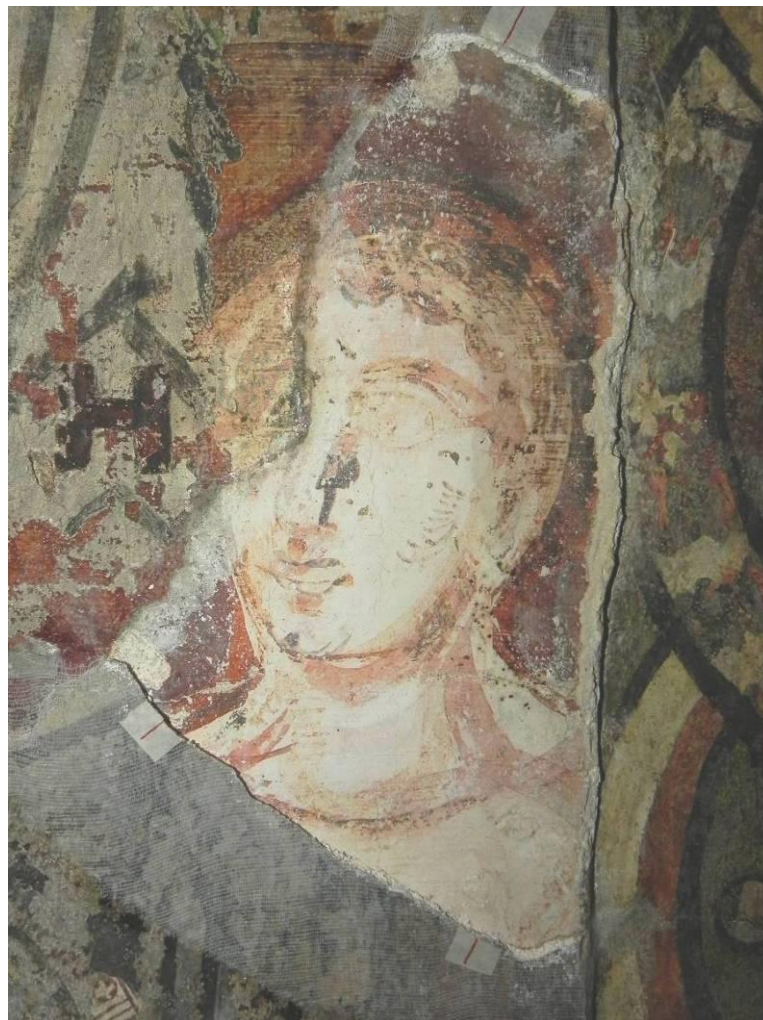
Figure 14

The removal of two detached fragments from the third phase (Figures 14, 58 and 59) has enabled us to study certain features of the paint layer. Once the preparatory drawing was completed, the artist painted in the flesh tones with a light pink obtained by mixing white and a little red earth. At the same time, the draperies were painted with red and yellow earth pigments. Next, the design was traced over with a thinner dark red line and the haloes were painted in the same color. Subsequently Egyptian blue mixed with white was used for the tunics and the sky. The darker details of the robes, hair, some facial features and decorative touches such as the small crosses were then added. The blossoms and fruit on the trees were added in a heavier dark pigment before the application of the green encaustic pigment, now lost (Figure 17). The blossoms between the apostles stand out clearly against a black background that also throws the figures of the twelve saints into strong relief. Finally, touches of white were applied as highlights and finishing.

With the agreement of the project management, it was agreed to remove two fragments of third-phase plaster in the east apse. These fragments were seriously detached and isolated by deep cracks from the surrounding areas of the painting. The operation, already partially studied and planned during the previous mission, was intended to improve the state of preservation of the plaster and the detachment of fragments inside the vault. It also enabled us to reveal pieces of second-phase plaster and study the working methods and original materials.

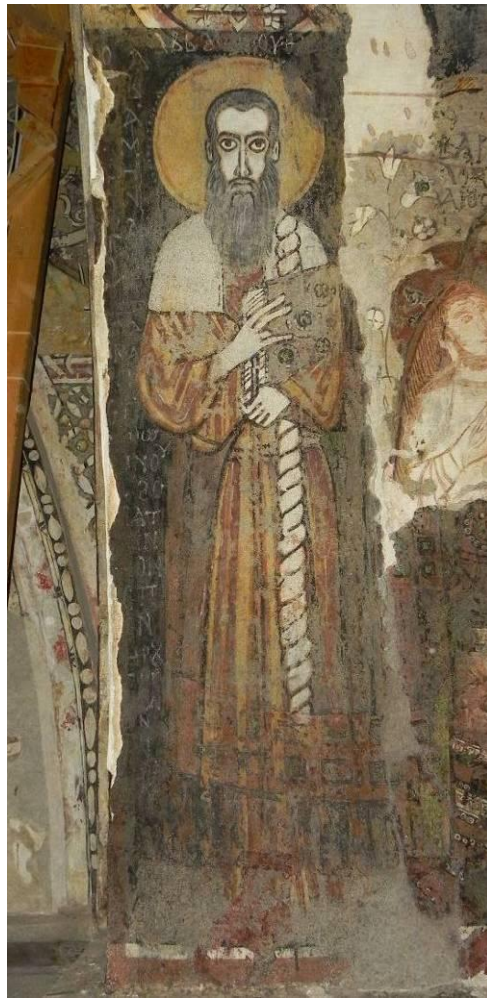
Figure 28

The saint⁷ (Figure 28) painted on the left of the area beneath the arch, overlying the fourth-phase band with circle and plant motifs, appears to belong to this same phase.

Although the fourth phase plus is extremely patchy, it is still preserved in the lateral areas and we can admire the features of the working method from the upper part of the archangel Michael and the front-facing figure of the saint depicted in the area beneath the arch. The lower part of the saint is particularly badly affected by detached plaster and micro-gaps that reveal the gem-studded decoration of the robe of the archangel beneath (see Figure 28).

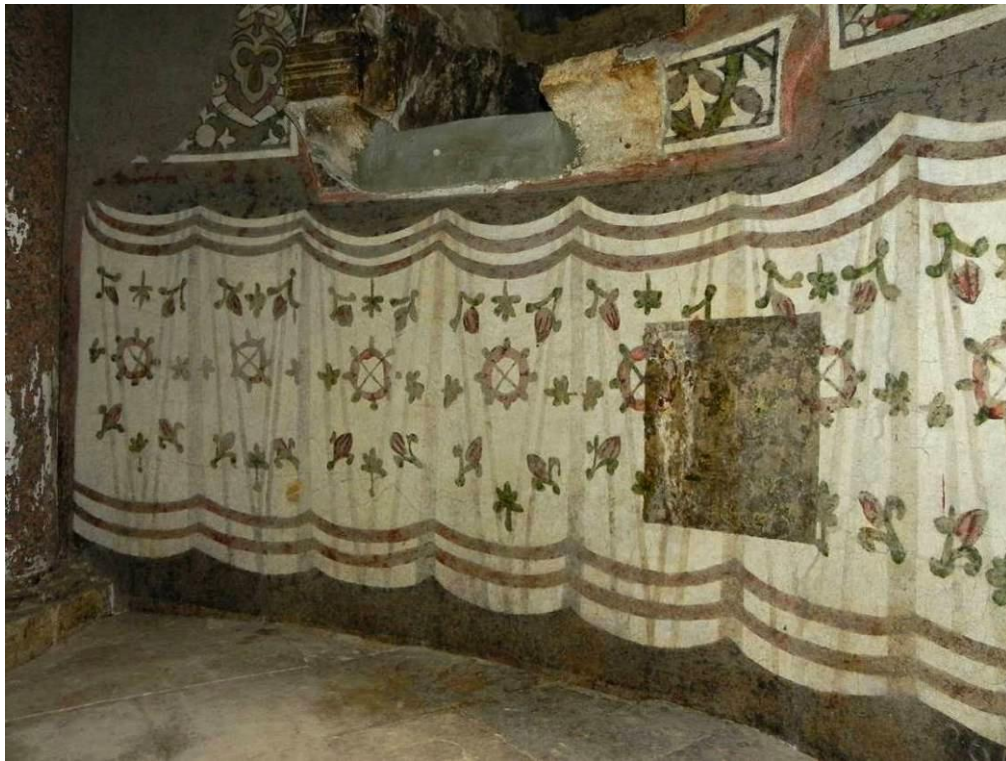
Figure 29

In the first tier, the third-phase *velaria* extends in a horizontal band below the three niches. The cleaning work has brought to light an area of elegant painting that is still worthy of admiration, despite its patchy state (Figure 29).

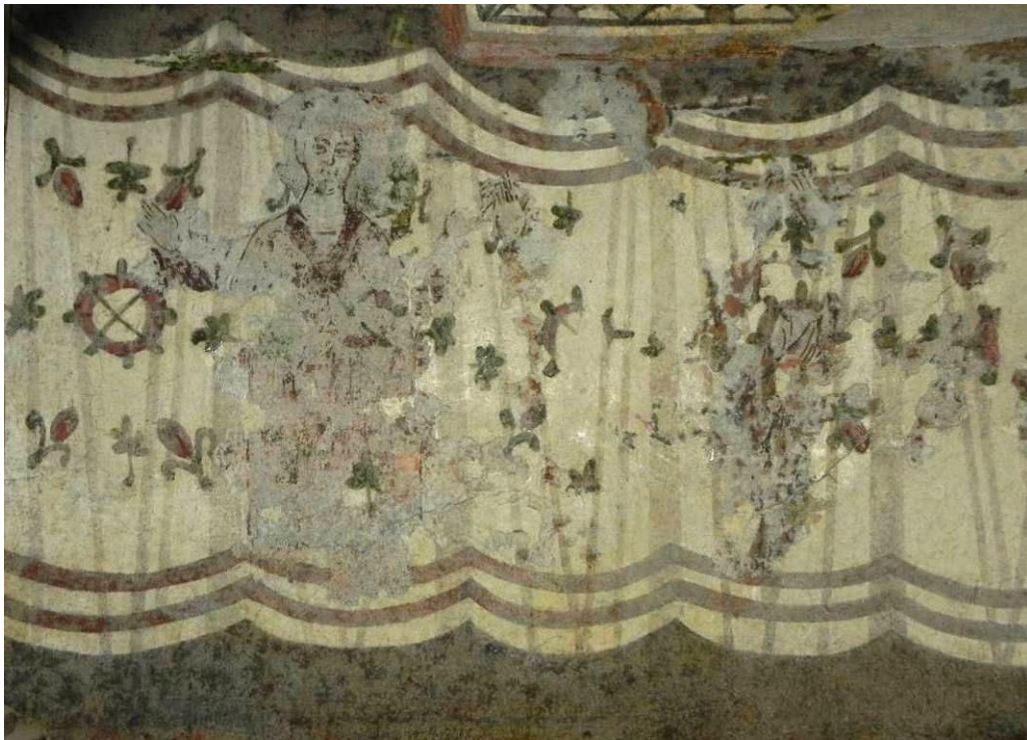
Figure 30

The fourth phase painter applied his trademark whitewash to this surface, in the central area between the two granite columns. Three haloed beardless figures at prayer are depicted here (Figure 30), although they are extremely patchy. One sketched-in detail seems to depict a number of flames, possibly intended to suggest a fire below. Although poorly preserved, originally the scene must have been finely painted and the backgrounds still bear a few significant fragments of encaustic green.

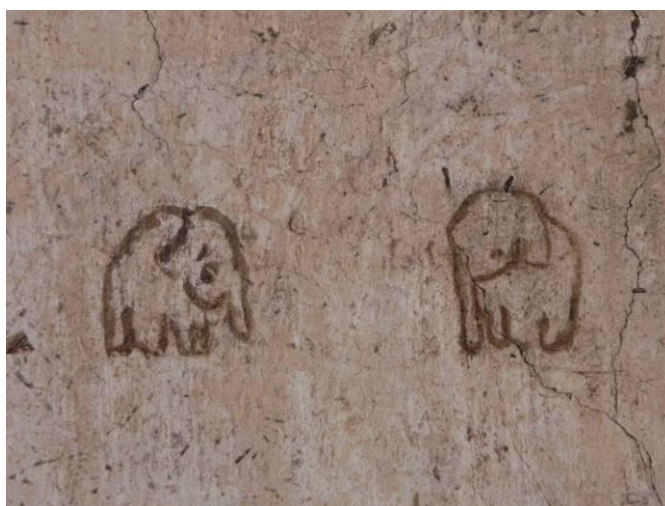
Figure 34

Finally, the discovery of two tiny drawings of elephants should be noted (Figure 34). These were drawn directly onto the plaster further to the right on the same wall.

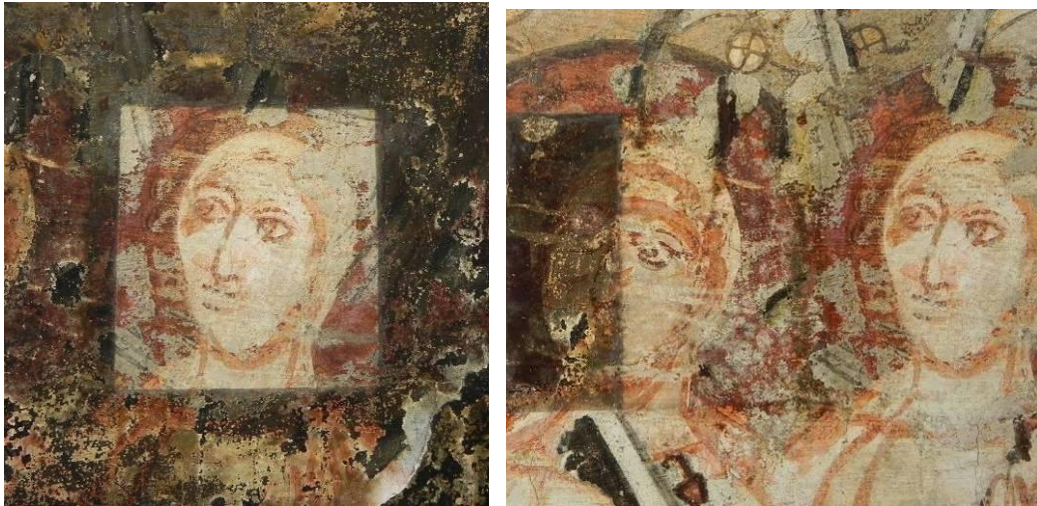
Figures 45 and 46

Continuous deposits of dirt (Figure 68) made up of particulate matter and carbon residues were removed by dabbing with a simple solution of ammonium carbonate (70 g/l in

distilled water). Sometimes a sheet of Japanese paper was placed between the pad and the surface and the pad rolled over it (Figures 45 and 46).
